SC Wing Safety Notification

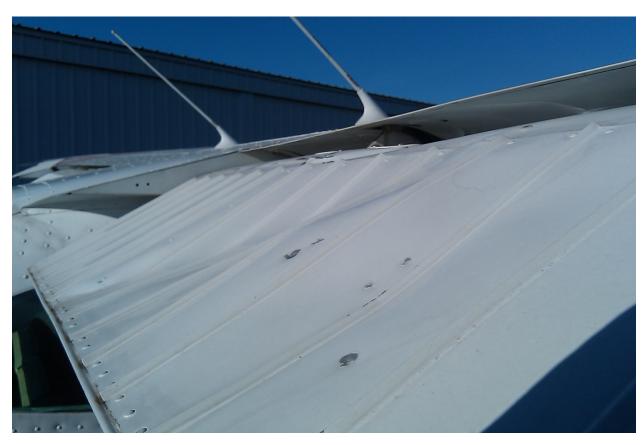
During the pre-flight inspection, the pilot was following the checklist and during the flap extension the pilot heard a loud "pop" and immediately stopped the flap extension by pulling the flap circuit breaker. Upon initial investigation it was discovered that the flap was jammed and twisted.

Upon further investigation, A&P mechanics determined that the probable cause of this incident was because of a jamming condition most likely created between a broken flap track support bracket and the flap roller arm assembly. The inboard flap track support bracket likely failed as a result of excessive wear or shear from the flap roller arm not having sufficient clearance to avoid contact with the bracket during operation. The dislodged/broken support bracket then re-positioned into the flap track assembly area and jammed/twisted the flap.

The pilot followed the established proceudres per the checklist. Additionally, it is clearly evident that there was a solid foundation of systems knowledge that was very beneficial. This situation is not an initial occurance. Cessna has issued a service bulletin (SEB95-3) to address the issue associated with the cracking on the flap track.
